ST. JOE STATE PARK DAM
ST. FRANCOIS COUNTY, MISSOURI
MO 30277

PHASE 1 INSPECTION REPORT NATIONAL DAM SAFETY PROGRAM

PREPARED BY: U. S. ARMY ENGINEER DISTRICT, ST. LOUIS

FEBRUARY 1980

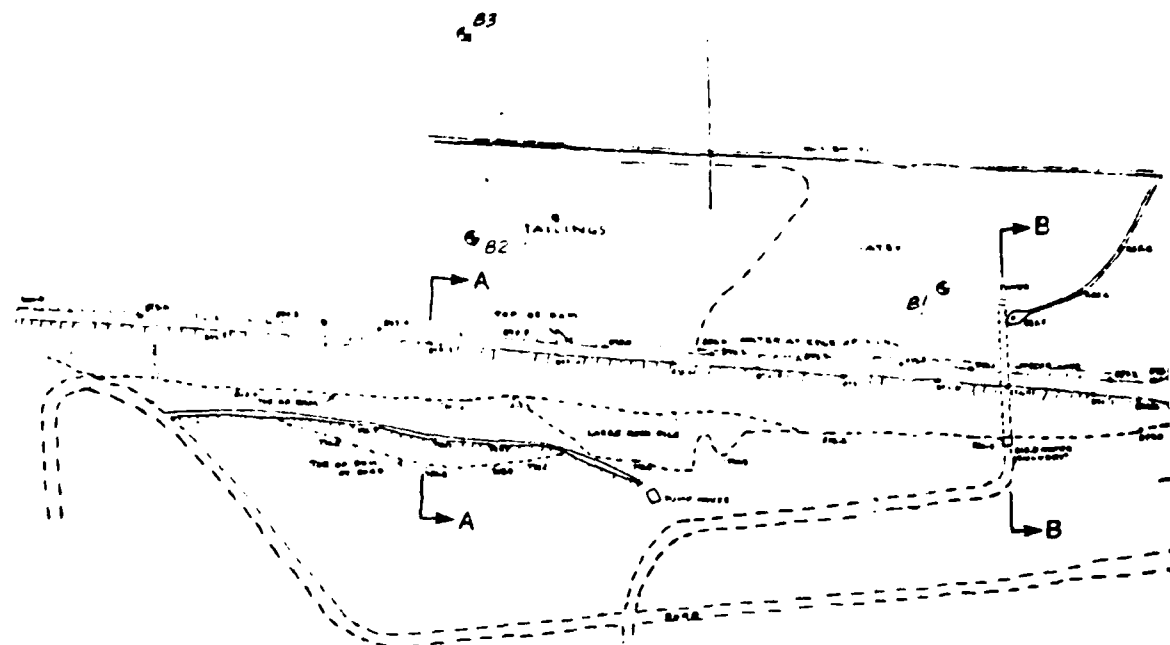
PLAN VIEW OF ST. JOE
TAILING DAM AND BORING LOCATIONS
FIGURE 1
